# Implementation of a Low-Profile Micropressure Support Surface for the Prevention of Perioperative Pressure Ulcers in Cardiac Surgery Patients

Presented at Fall SAWC, Las Vegas, Oct 20-22, 2017 – selected as the best abstract in Clinical Research section

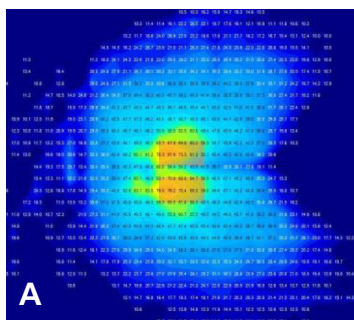
**Fig A:** Interface pressure (IP) map of male subject's pelvic area, lying on OR pad alone.

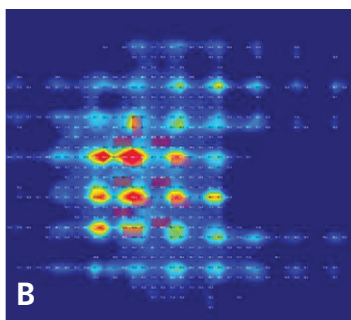
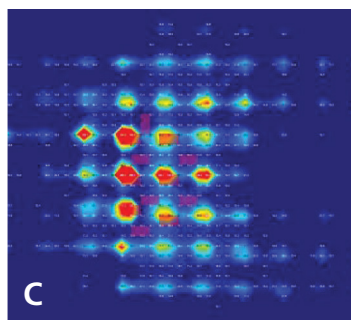
**Fig B and C:** IP maps of pelvic area with subject lying on the overlay placed on top of the OR pad while Zone 1 (Fig B) and Zone 2 (Fig C) are inflated. Red colors indicate IP of 100 mm Hg or higher.

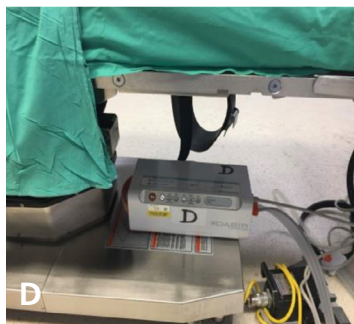
**Fig D:** The AP control unit was initially placed on the foot pedestal of the OR table.

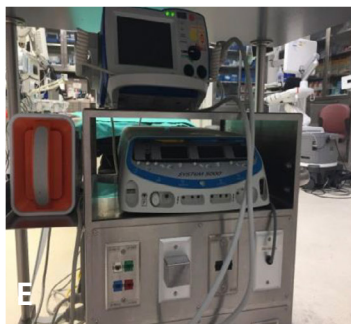
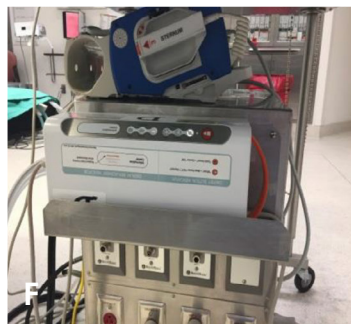
**Fig E and F:** To eliminate radio frequency interference between the AP control unit and improve visibility, the control unit was moved to custom-engineered mounting brackets located at the foot of the bed.

The micropressure support surface was employed for 2,056 cardiac operations during the evaluation period. Feedback forms were completed by OR staff for 364 cases (average surgery duration  $4.8 \pm 1.1$  hrs, BMI  $29.0 \pm 6.0$ ). Radio frequency interference between the surface and the electrocautery unit and overlay-control unit connection were identified as potential concerns by OR staff. For cases where feedback forms were available, there were zero perioperative pressure injuries after implementation of the micropressure support surface.
